**US Army Corps
of Engineers®**
Engineering and Support Center,
Huntsville

Mishap Lessons Learned

Subject: Electrical – Near Miss

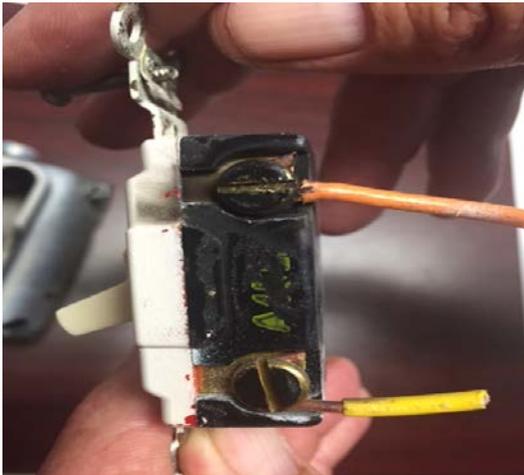
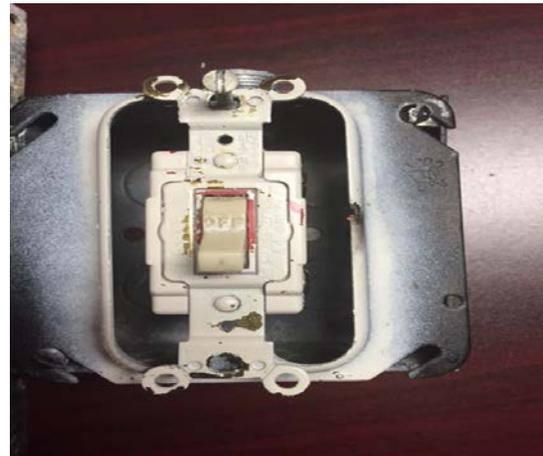
The employee was removing a diamond steel plate, light switch and receptacle. These items were being removed so that a new door and frame could be installed. The employee removed the light switch cover then proceeded to remove the light switch which was on top of the diamond plate. The employee removed the switch by pulling it from the box. He then was able to remove the diamond plate and reinstall the light switch. While attempting to reinstall the switch, the employee touched the side of the junction box with either the switch or the wire coming from the switch causing an electrical short and a breaker to trip. The emergency generators started to provide power as designed, so there was no loss of power to facility operations. The employee was working alone and was not injured.

- The employee was not qualified to remove the light switch from the junction box, nor did he follow prime contractor's safety procedures.
- LO/TO was not used nor did the employee check for power.
- A qualified electrician should have been called to implement LO/TO and verify the system was not energized.
- The employee took it upon himself to remove the light switch. This caused an electrical short and the breaker to trip affecting the 1st thru 4th floor of the facility.
- After further investigation it was found that the light switch the employee was removing was powered by a 277 volt circuit.

Isolation in accordance with EM 385-1-1 is required to be accomplished by a qualified person before work begins.
