**US Army Corps
of Engineers®**
Engineering and Support Center,
Huntsville

Mishap Lessons Learned

Subject: Counterbalance Mounting Plate Weld Failure

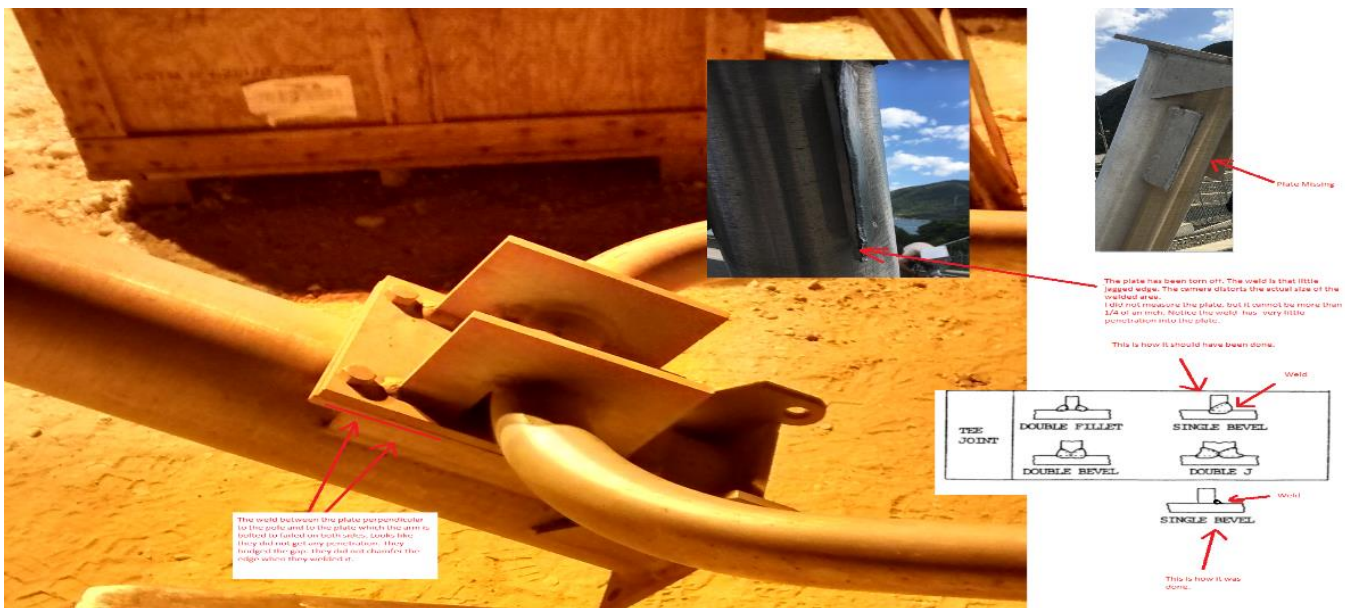
Event: On-site technician was raising the camera pole using the approved counterweight assembly attached to the matching bracket welded to the pole. This is a correct and tested procedure. During the raising process, the welds holding the pole-mounted plate broke free causing the pole to drop a distance of 6 feet to the road surface. The technician was able to avoid the falling pole, but damage resulted to at least one of the two cameras mounted on the camera pole. An on-site engineer examined the weld on the plate and determined the weld itself to be defective with no traces of corrosion or other damage.

- **Improper welding technique** - Welds for the plate were “button type” tack welds that cannot physically stand up to repetitive lifting and lowering stresses.
- **Corrosive (salt air) environment** - Tack welds allow the corrosive air to impact all exposed metal surfaces and gradually atrophies and weakens the plate-to-pole bond.

- Inspect critical connections and surfaces
- Maintain a safety zone during lifting/lowering ops
- Affix a safety cable to prevent/mitigate drops
- Always have and wear appropriate PPE06
- Broadcast incident details to all sites
- Suspend all raising/lowering of poles & conduct pole plate checks
- Contact manufacturer for repair actions
