**US Army Corps  
of Engineers®**  
Engineering and Support Center,  
Huntsville

# Mishap Lessons Learned

**Subject:** Laceration on Back of Hand

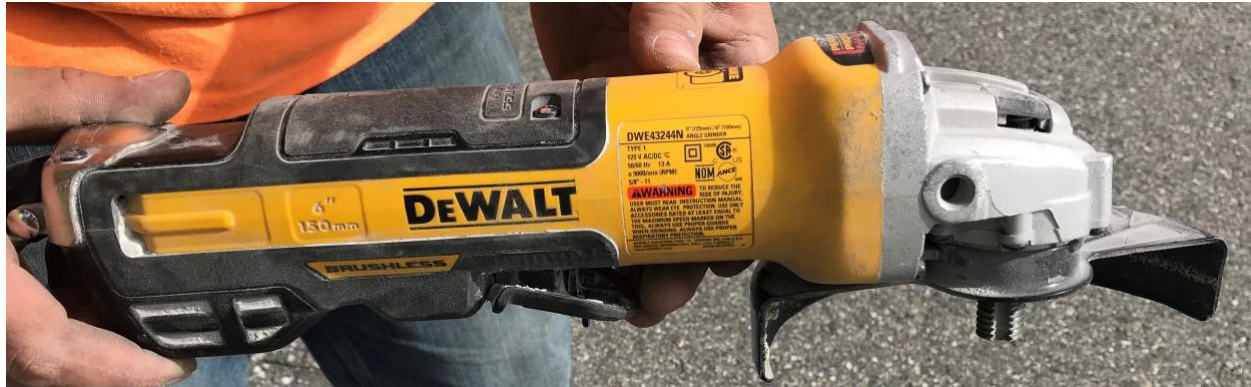
**Event:** Employee was utilizing a DeWalt heavy-duty grinder (see picture below) equipped with a wire brush to prepare for repairs on crack and expansion joints in a concrete containment. Employee was holding the grinder with the right hand when the grinder jumped from the expansion joint and hit the back of his left hand and lacerated it. Employee was taken to a clinic and received 12 stitches before returning to work.

**Direct Cause:** Employee did not follow power tool manufactures requirements; one hand on the grinder (the manufacturer requires two hands).

**Indirect Cause:** The side handle was missing from the grinder (required by manufacturer) and the employee was not wearing proper PPE (leather gloves) as required by the AHA.

**Recommendations:** Read manufactures requirements prior to use of power tools and follow the requirements and recommendations. Review the Activity Hazard Analysis prior to starting a task and ensure all controls are adhered to. Leather gloves required by the AHA were not used. Use of the gloves could have lessened the severity of the injury.
