**US Army Corps  
of Engineers®**  
Engineering and Support Center,  
Huntsville

## Mishap Lessons Learned

**Subject:** Lacerated Fingers

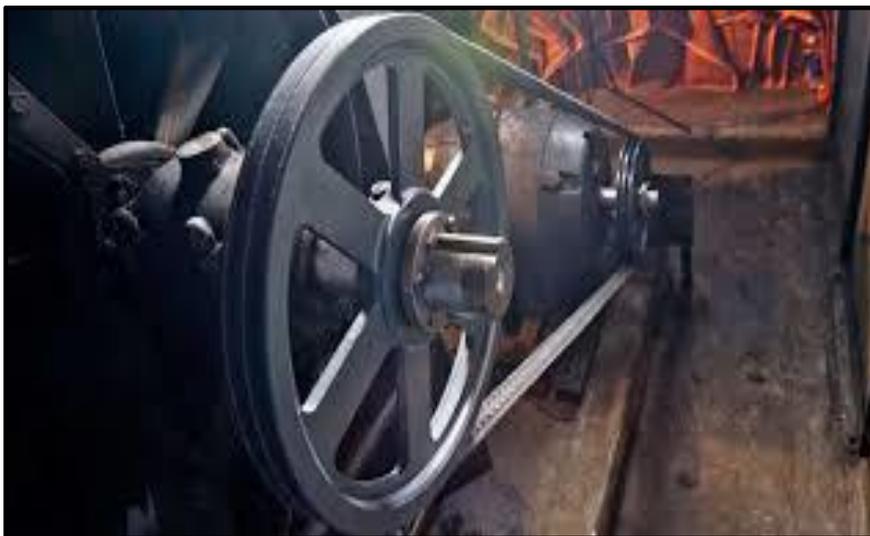
\*Photo for demonstration purposes only

**Direct Cause(s):** The technician was pulling the belt with his hands to get it to “roll” onto the sheave and when it did his fingers were caught between the belt and the sheave causing the lacerations.

**Lessons Learned:** The AHA and the manufacturer's directions should be reviewed and followed when maintaining equipment. The motor bolts should be loosened to ease the tension on the belt to allow it to be changed safely. A common practice in the industry may not always be the safest way to accomplish a task.

The contractor updated the AHA's and provided the manufacturer's directions on how to change the belt. The correct way to change the belt requires the motor mounts to be loosened and the motor moved forward. This will require the motor pulley and the fan pulley to be re-aligned. The contractor purchased a laser alignment tool to help speed the alignment of the motor and the sheave after the new belt was installed. The technicians are now required to review the updated AHA and manufacturer's instructions and must be trained on the use of the alignment tool.
