**US Army Corps
of Engineers®**
Engineering and Support Center,
Huntsville

Mishap Lessons Learned

Subject: Near Miss Incident involving a Crane and Swing Stage Scaffolding

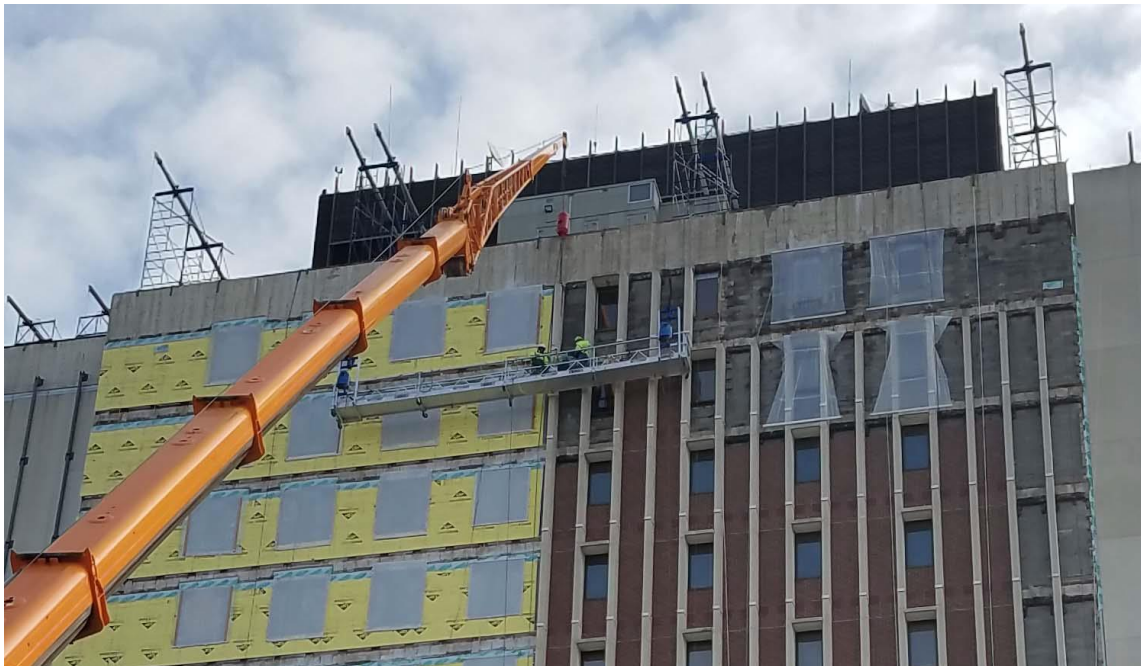
Event: A crane operator thought the signalman/rigger on a hanging scaffold was calling for the ball. He slowly lowered the ball but it extended too far and made contact with the hanging scaffold. The operator mentioned there was static or other speakers on the radio that may have caused the error. Fortunately no property damage or injury resulted from this significant near miss.

Picture is an illustration of the crane configuration at the time of the near miss.

Root Cause: Operator Error. Clear communications were not established prior to lowering the ball.

Indirect Cause: Not following the AHA in the Critical Lift Plan which states to “Establish and maintain communication” and that “All load movements will be made under the direction of the signal person”. Allowing others to use the same communications line.

Recommendations: Designated/dedicated radio channels should be established for the crane operator and signalman. Disciplinary action should be established for any unauthorized personnel using these channels. If communication is broken, an “All Stop” should be immediately enacted until coms can be re-established. Ensure all workers have reviewed the AHA. Crane and Scaffolding were inspected by QPs before going back to work.
