Safety Office

Mishap Lessons Learned

Subject: Underground Conduit/Excavator Incident

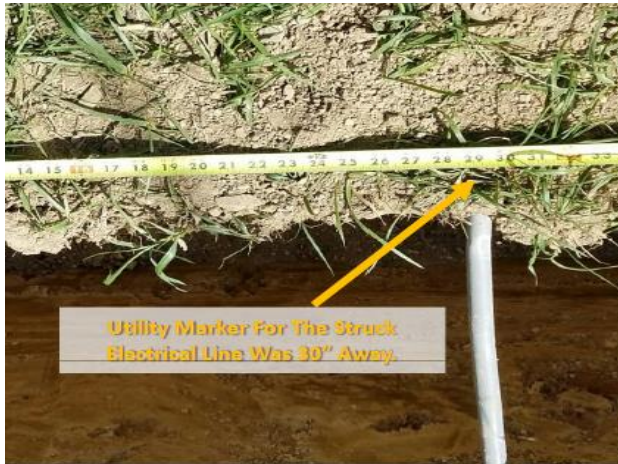
Event: An underground conduit was struck while digging a gas line trench. Prior to the incident a locator was used to detect utility lines along the trench path. No utilities were found so the operator started exploratory digging which is a scraping motion with the excavator bucket to uncover suspected underground installations. It was during this operation that the utility line was uncovered and damaged. There was a spotter working in coordination with the excavator, there were no injuries to either of the workers. Post incident inspection identified damage to the wire conduit but the wires remained intact. The excavator was not damaged.

- The Contract did not contact the local utility company or owners of area before starting excavation work.

- The Contractor needs to contact the local utility company or owners within established or customary local response times, advised of the proposed work, and asked to establish the location of the utility underground installations prior to the start of actual excavation.
